REPRESENTATIVE PHOTOGRAPHS - SWPPP INSPECTION

Pilot Travel Center

October 28, 2021

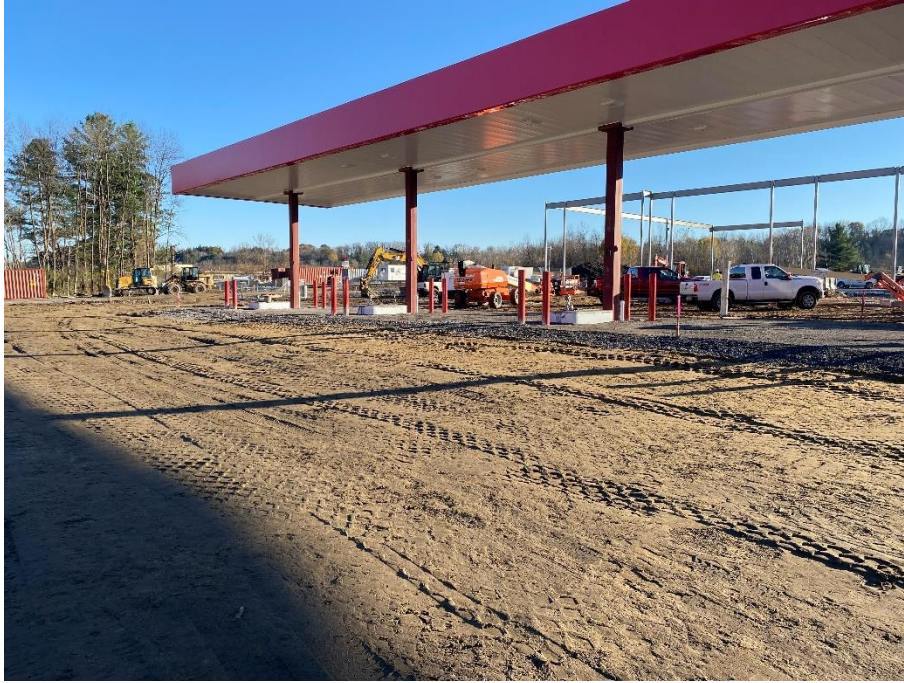
Figure 1 - View subbase grading for gas pump area, looking southeast.

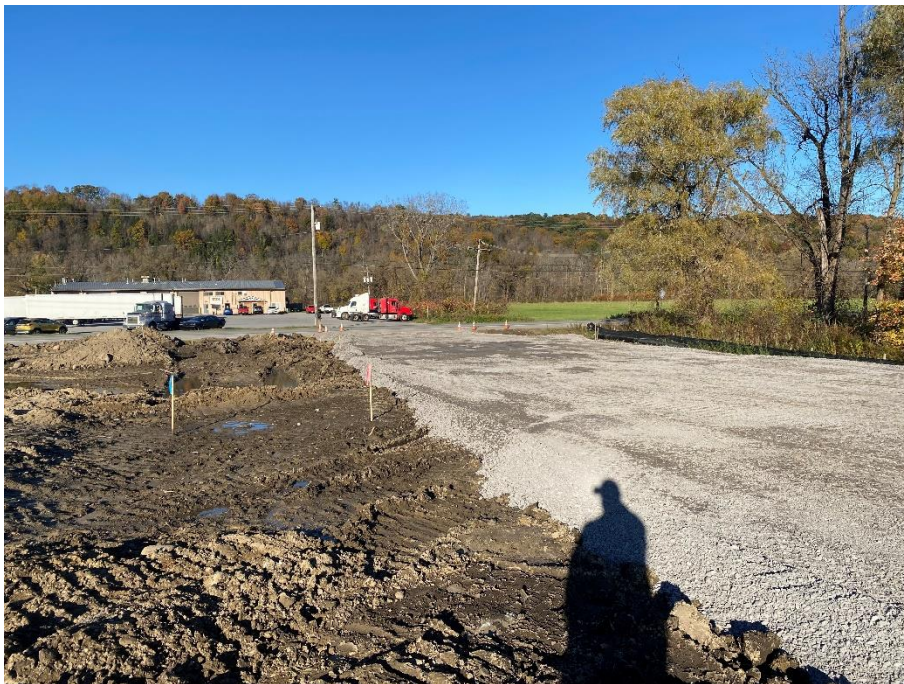
Figure 2 - View of subbase grading for eastern driveway, looking north.

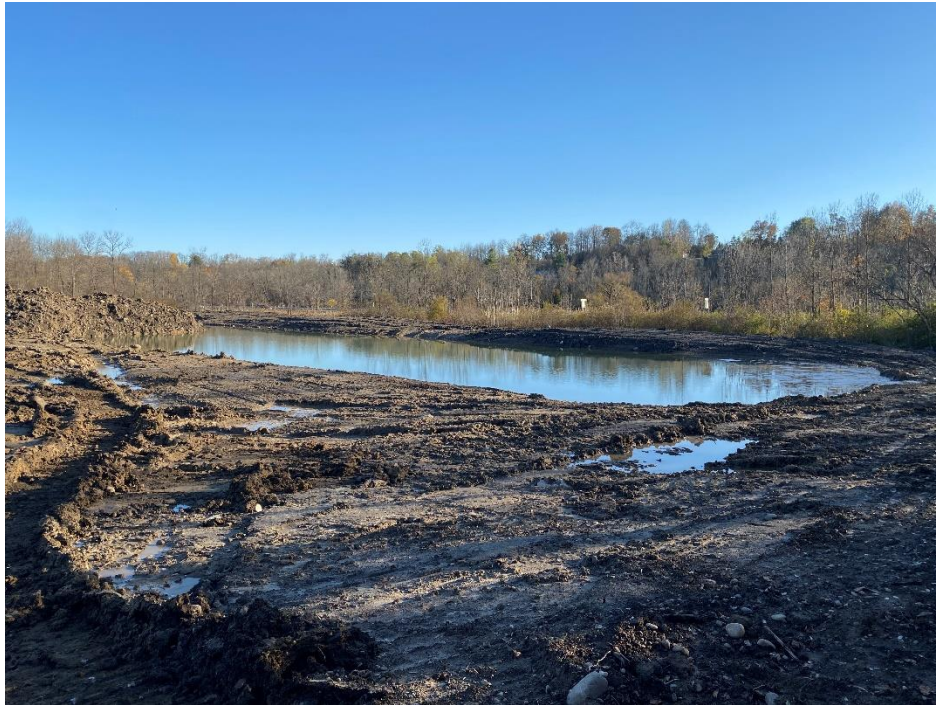
Figure 3 – View of stormwater pond at south end of site, looking southeast.

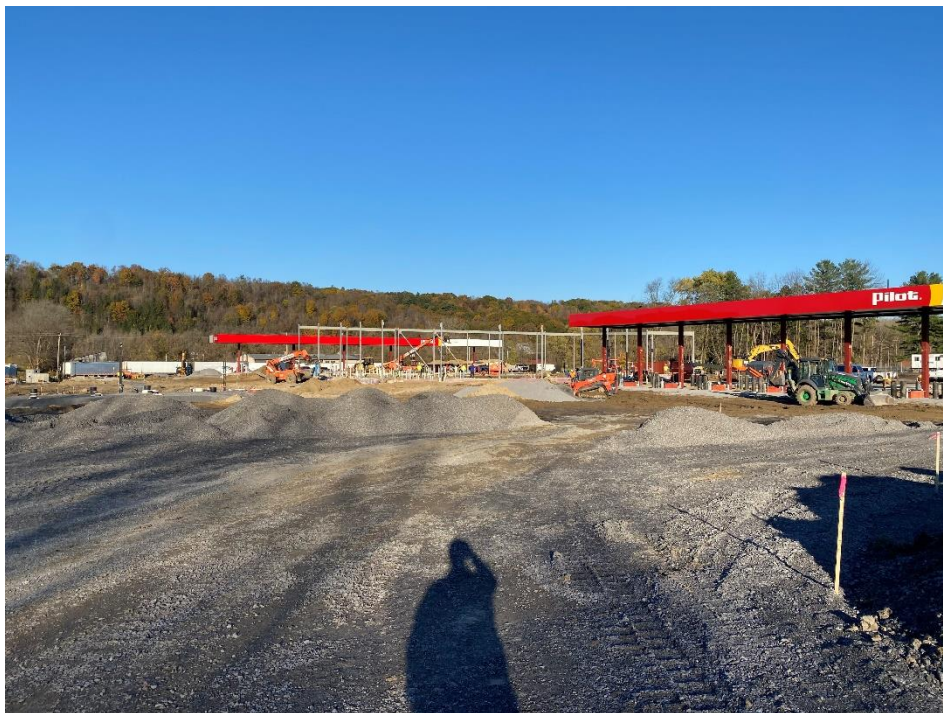
Figure 4 – View of subbase grading along western side of site, looking north.

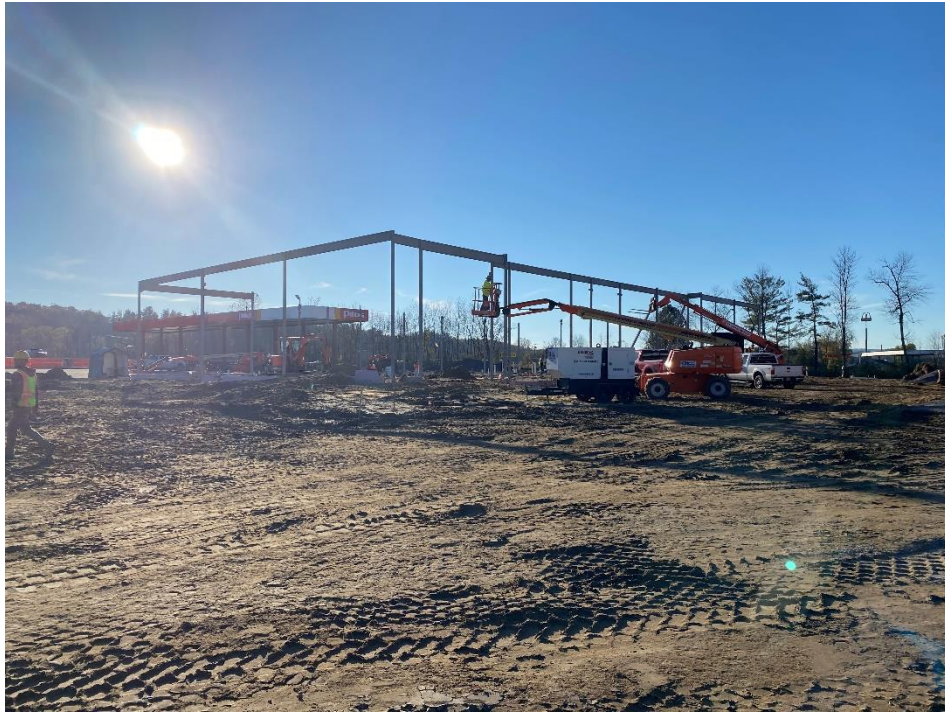
Figure 5 - View of steel erection for building, looking southwest.
