REPRESENTATIVE PHOTOGRAPHS - SWPPP INSPECTION

Pilot Travel Center

November 2, 2021

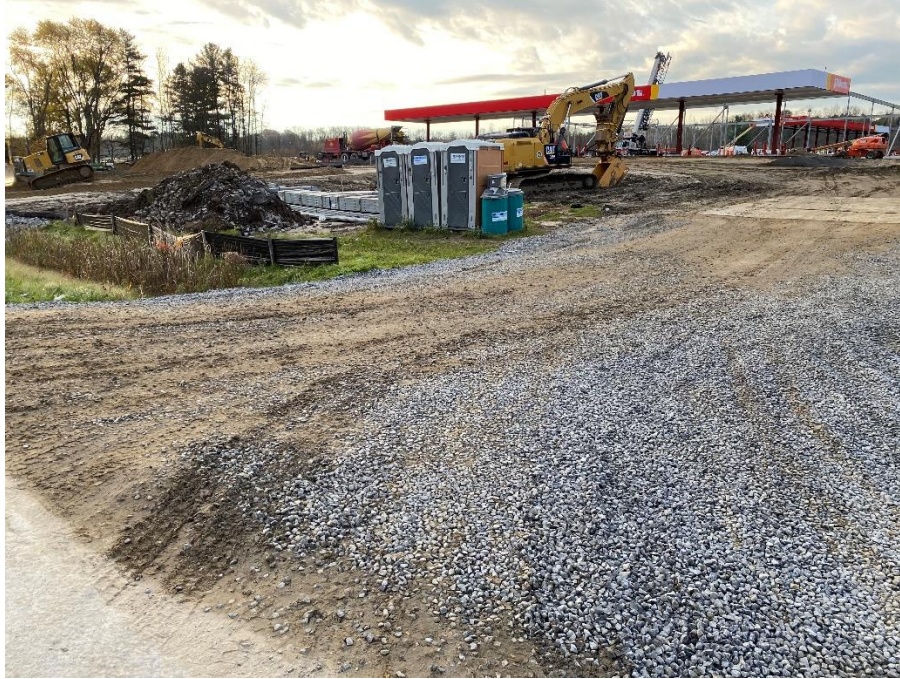
Figure 1 - Refresh the compacted stone for the construction entrance.

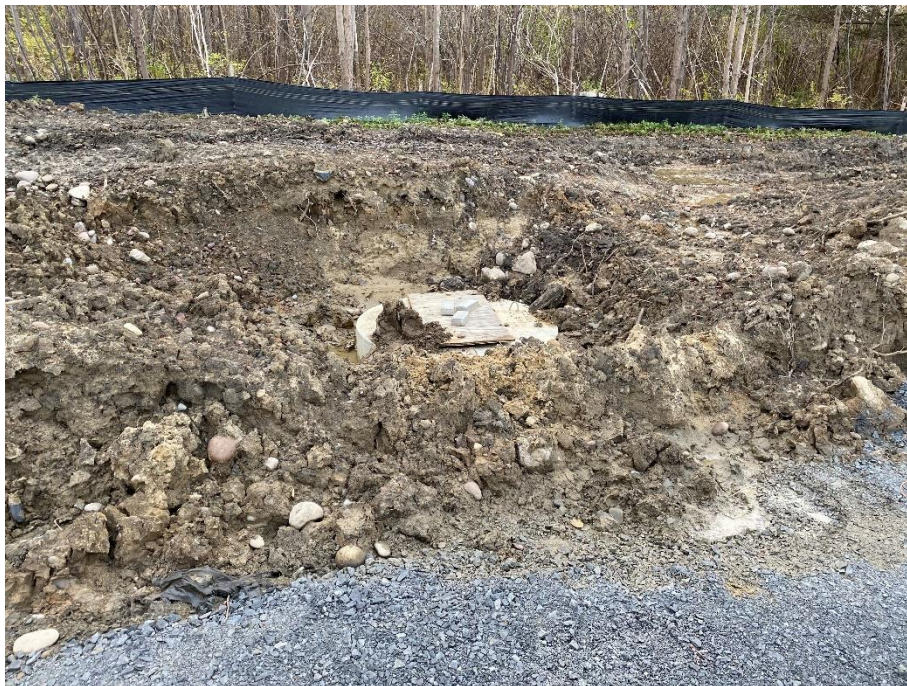
Figure 2 - Add inlet protection around low structures.

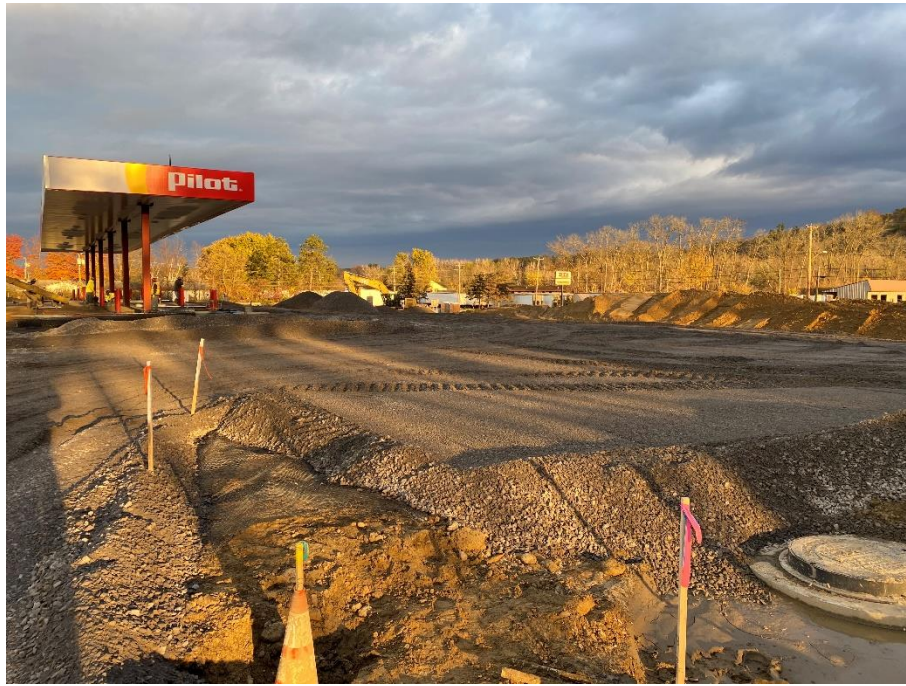
Figure 1 – View of subbase grading for front parking area, looking northwest.

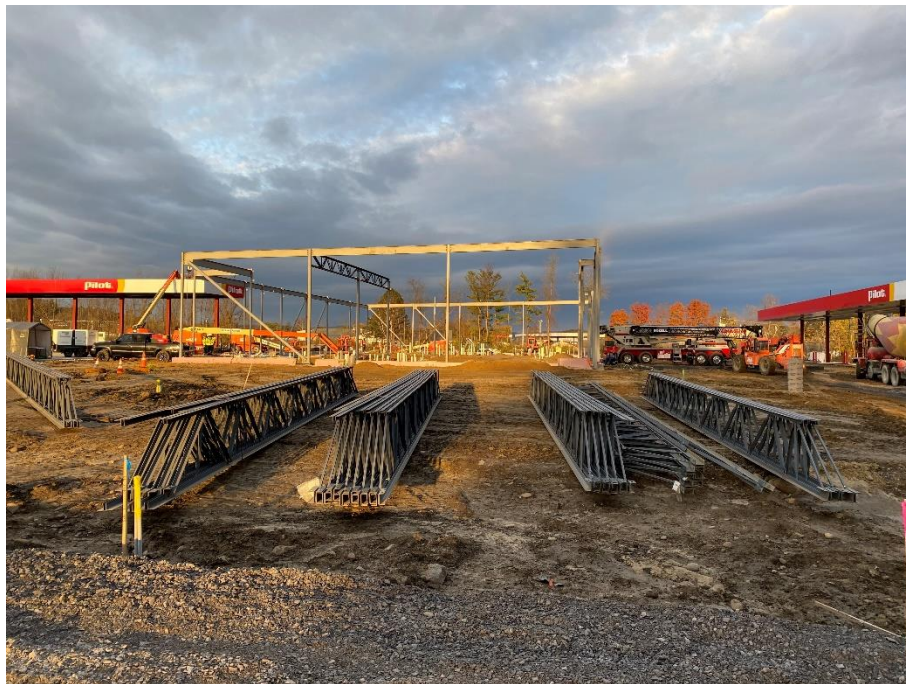
Figure 2 – View of steel erection for building, looking west.

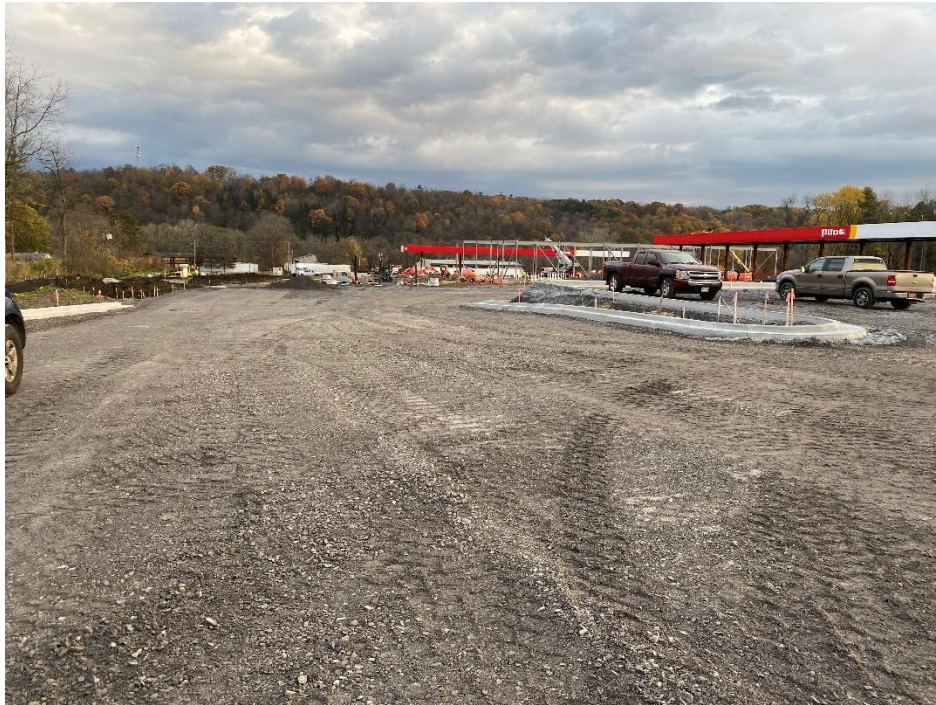
Figure 3 - View of subbase grading for western side of site, looking north.

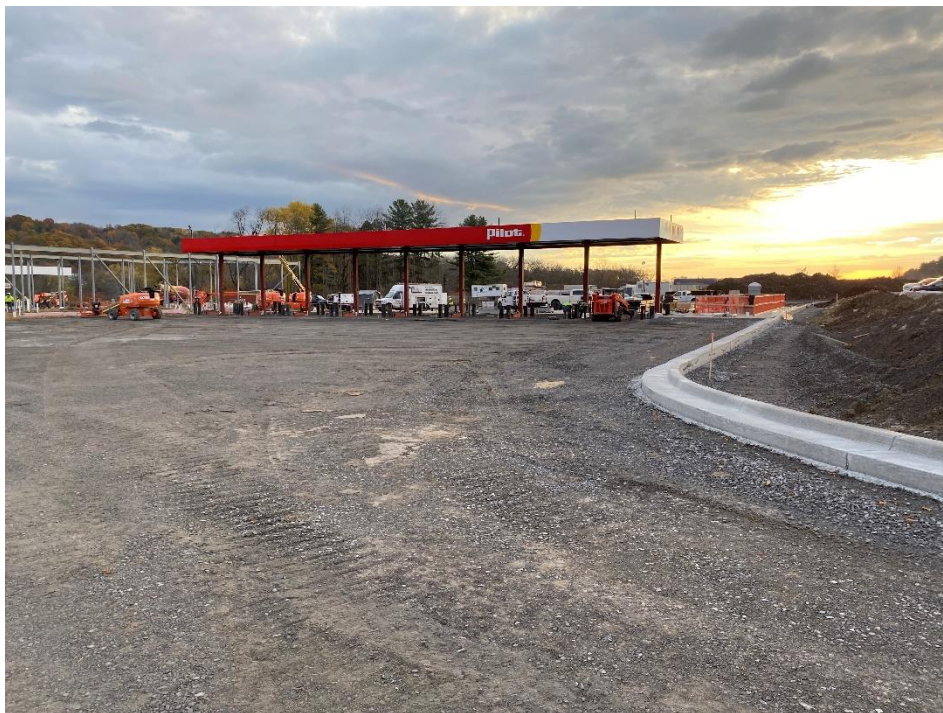
Figure 4 - View of subbase grading for truck fuel pump area, looking northeast.

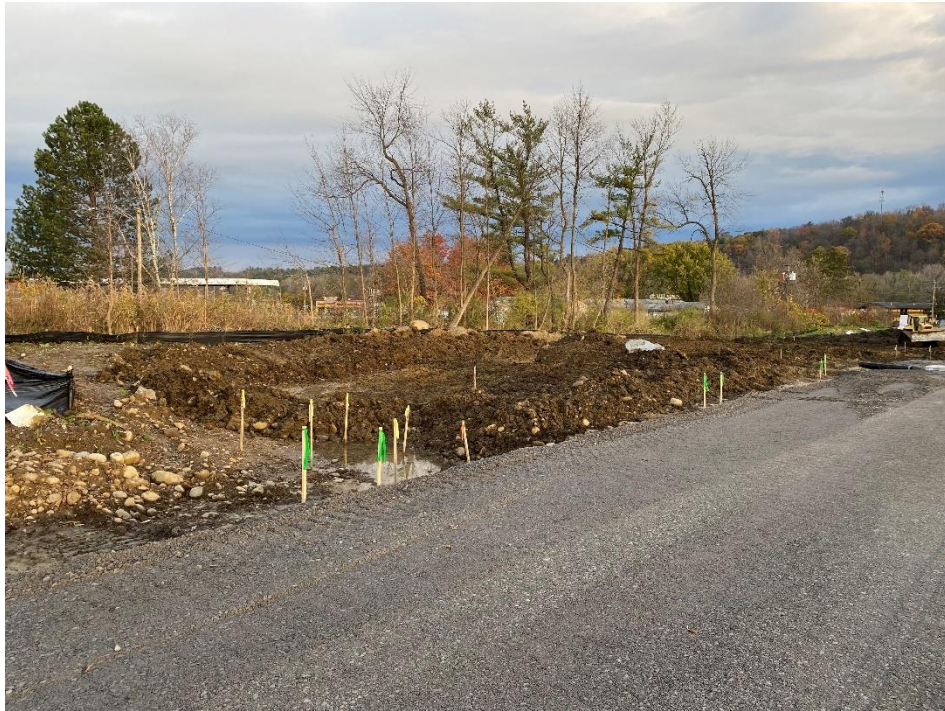
Figure 5 - View of grading for bioretention area along west side of site, looking northwest.
