WETLAND AND STREAM DELINEATION REPORT

411 Reynolds Road Town of Glen, Montgomery County, New York LaBella Project No. 2212382

Prepared By: LaBella Associates, D.P.C.

Date: August 2021

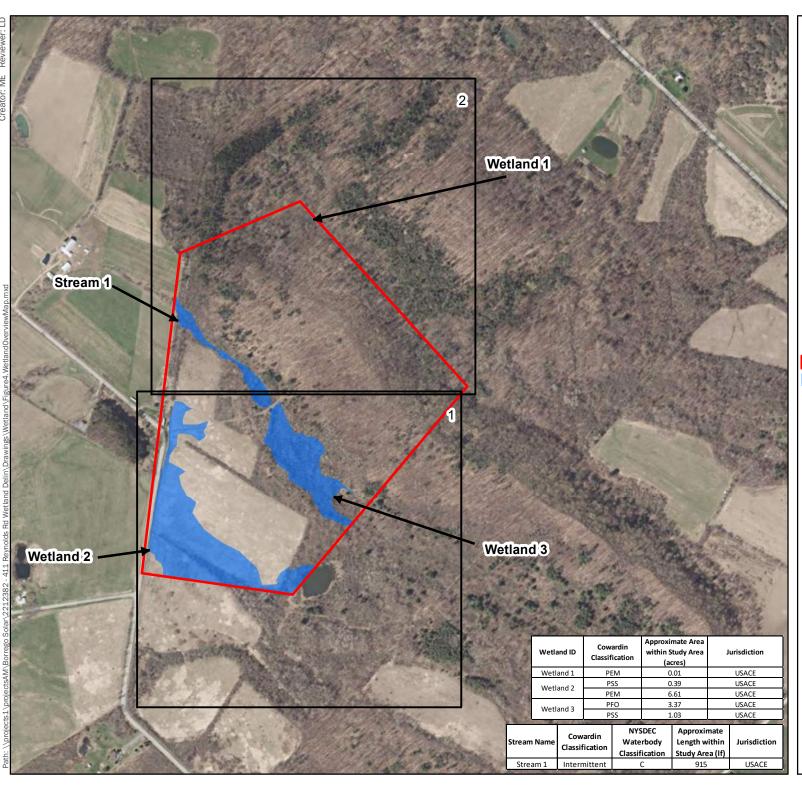
FIGURE 4

Wetland and Stream Overview Map

LaBella field staff delineated three wetlands within the Study Area, consisting on one palustrine emergent (PEM) wetland, one mixed palustrine forested (PFO) and palustrine scrub-shrub (PSS) wetland, and one mixed PSS and PEM wetland. One intermittent stream was also delineated within the Study Area (See Appendix A, Figure 4 and 5). Tables 4 and 5 provide areas and classifications of the delineated wetlands. The remainder of the Study Area is considered to be upland forest and old field communities, and these habitats lack wetland hydrology and hydric soils.

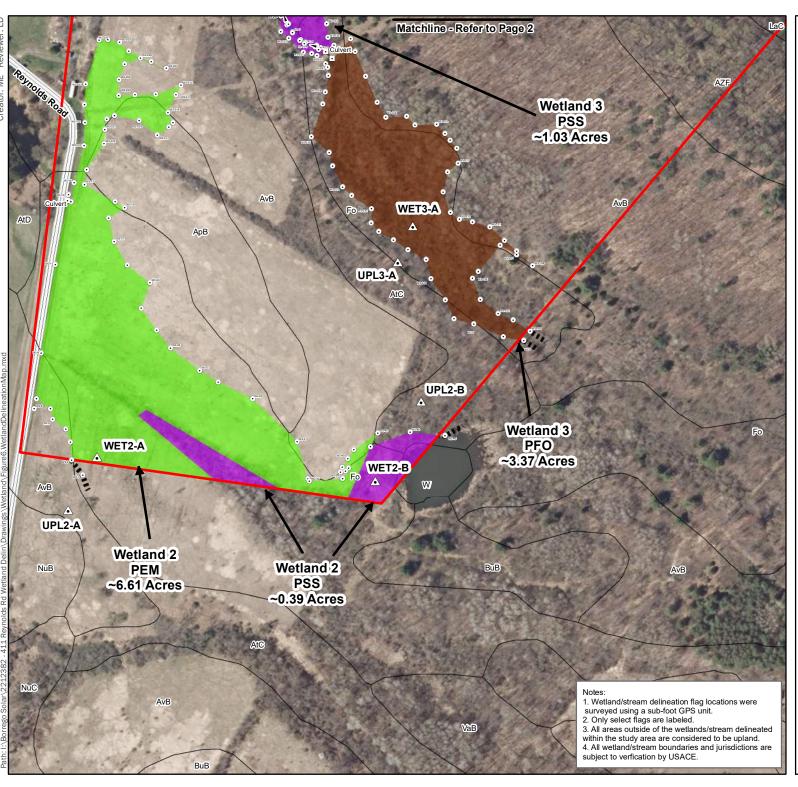
Wetland and **Stream Delineation Survey** FIGURE 5

Wetland and stream boundaries were defined in the field with sequentially-numbered pink surveyor's flagging or pink pin flags. Each flag was digitally recorded using a sub-foot Global Positioning System unit. Data and observations were collected from both wetland and upland data points within the Study Area. These data points were recorded on routine USACE Wetland Determination Data Forms (Appendix B).

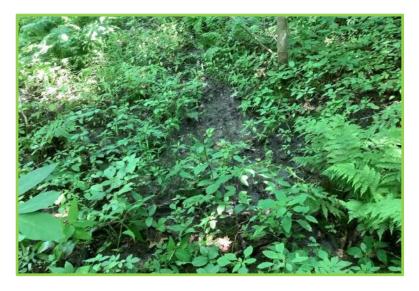
Vegetative Community within Wetland 1.

Wetland 1 is a small, 0.01-acre PEM wetland occupying a narrow band on the northern boundary of the Study Area. At the time of the field survey, observed indicators of hydrology included saturated soils (to the surface), microtopographic relief present within the wetland, and the vegetative community passed the FAC-neutral test. Surface waters appear to continue north offsite. Hydrology supporting Wetland 1 appears to be surface water from precipitation as well as ground water. Sensitive fern (*Onoclea sensibilis*) and jewelweed (*Impatiens capensis*) dominate the herbaceous layer within Wetland 1. The first 5 inches of the soil profile consist of loams with a dark yellowish-brown matrix (10YR 3/4). Below 5 inches, soils are dark gray (10YR 4/1) with dark yellowish-brown (10YR 4/6) redoximorphic concentrations found within the matrix.

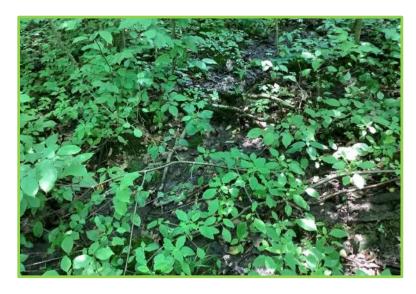
Vegetative Community within Wetland 1.

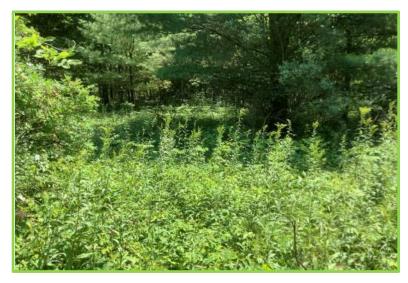
Typical view of Wetland 2.

Wetland 2 is a mixed PSS and PEM community located within a low lying area in the southern portion of the Study Area. The wetland totals 7 acres in size. It appears that the hydrology supporting Wetland 2 is from groundwater as well as surface water inputs from precipitation and sheet flow from the adjacent hillsides. At the time of the site visit, observed wetland hydrology indicators include saturate soils (to a depth of 8 inches), microtopographic relief, and the vegetative community passed a FAC-neutral test. Inundation is also visible on aerial imagery. Surface waters from Wetland 2 enter the Study Area from a pond area to the east, and continue west offsite.

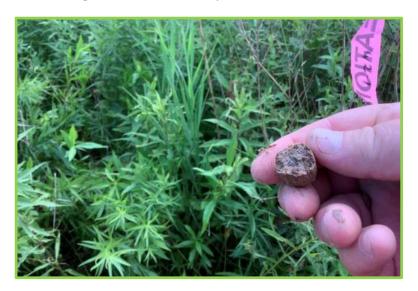
Soils sampled at data point Wet-2A.

Woody species found within Wetland 2 include willow (*Salix discolor* and *S. alba*), red osier dogwood (*Cornus sericea*), and nannyberry (*Viburnum lentago*). The herbaceous layer is dominated by grass leaved goldenrod (*Euthamia graminifolia*), late goldenrod (*Solidago gigantea*), reed canary grass (*Phalaris arundinacea*), jewelweed, purple loosestrife (*Lythrum salicaria*), woolgrass (*Scirpus cyperinus*), water hemlock (*Cicuta maculata*), climbing nightshade (*Solanum dulcamara*), dark green bulrush (*Scirpus atrovirens*), and marsh bedstraw (*Galium palustre*). Soils within Wetland 2 consist of loamy/clayey soils. Soils within the first 5 inches of the soil profile have a dark yellowish-brown matrix (10YR 3/4), and below 5 inches have a dark gray (10YR 4/1) depleted matrix with prominent yellowish-brown (10YR 4/6) redoximorphic concentrations.

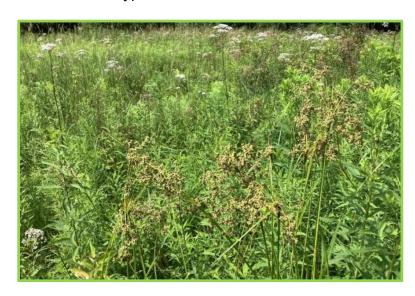
Vegetative community at data point Wet-2B.

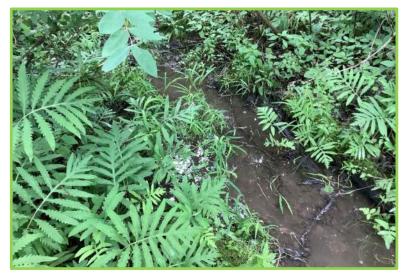
Stream 1 delineated within the Study Area.

Stream 1 is an intermittent stream that flows for approximately 915 linear feet within the Study Area, and is mapped as a NYSDEC Class C stream. The stream originates onsite at a culvert located beneath an access road that crosses Wetland 3. Surface waters from a forested portion of Wetland 3 flow into the stream channel, which continues northwest offsite. The stream width ranges from 2 to 4 linear feet within the Study Area, and has a silt and clay bottom.

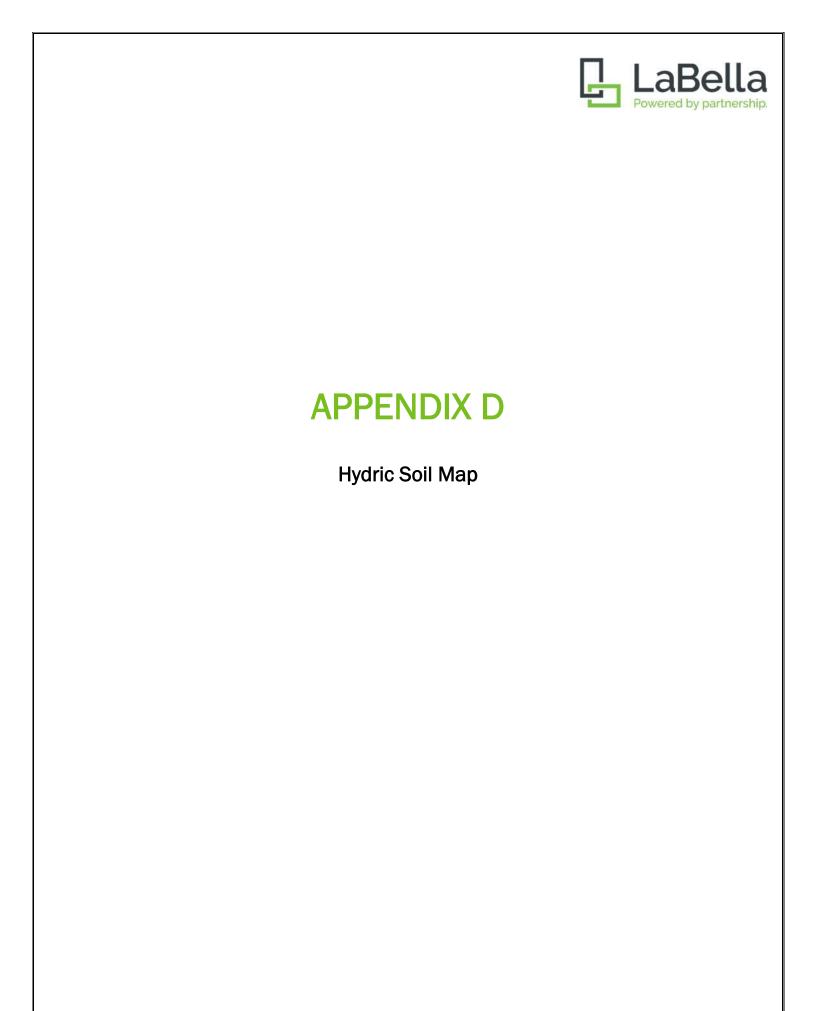
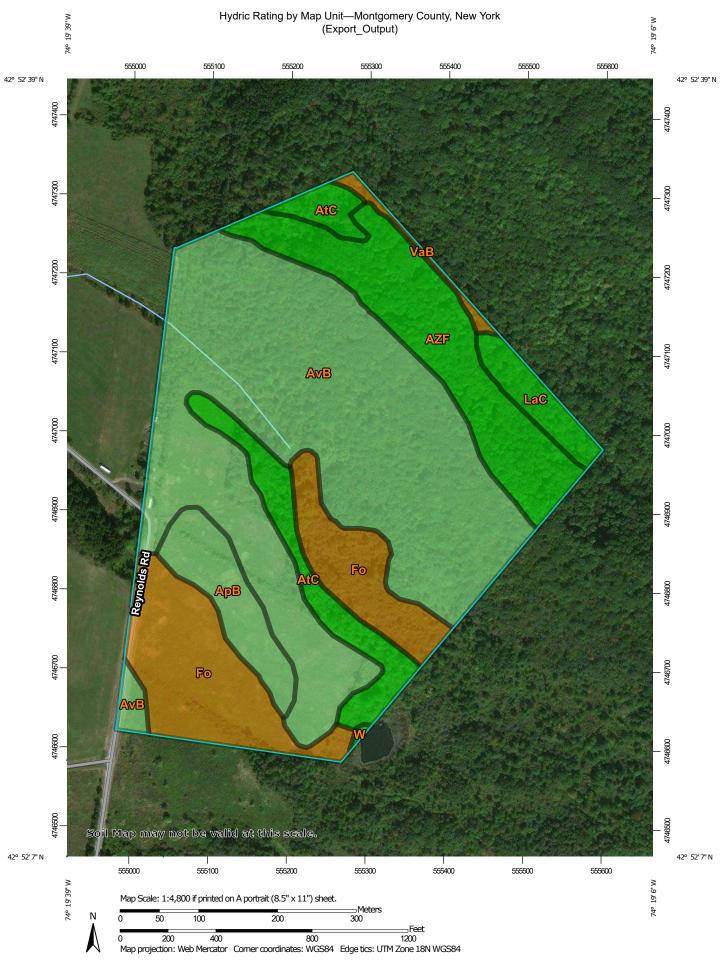
The Hydric Soil ratings outlined in Table 1 and the Web Soil Survey map provided in Appendix D, indicate there are four soil map units contain hydric components. Soils from the Appleton series, Arnot-Angola complex, Fonda series, and Varick series are considered hydric, with hydric ratings ranging from five to 85 percent.
