January 13, 2021  
File No. 01.0175344.00

Re: Geotechnical Report  
Proposed Ground-Mount Photo-Voltaic (PV) System  
2621 State Highway 5S  
Fultonville, New York

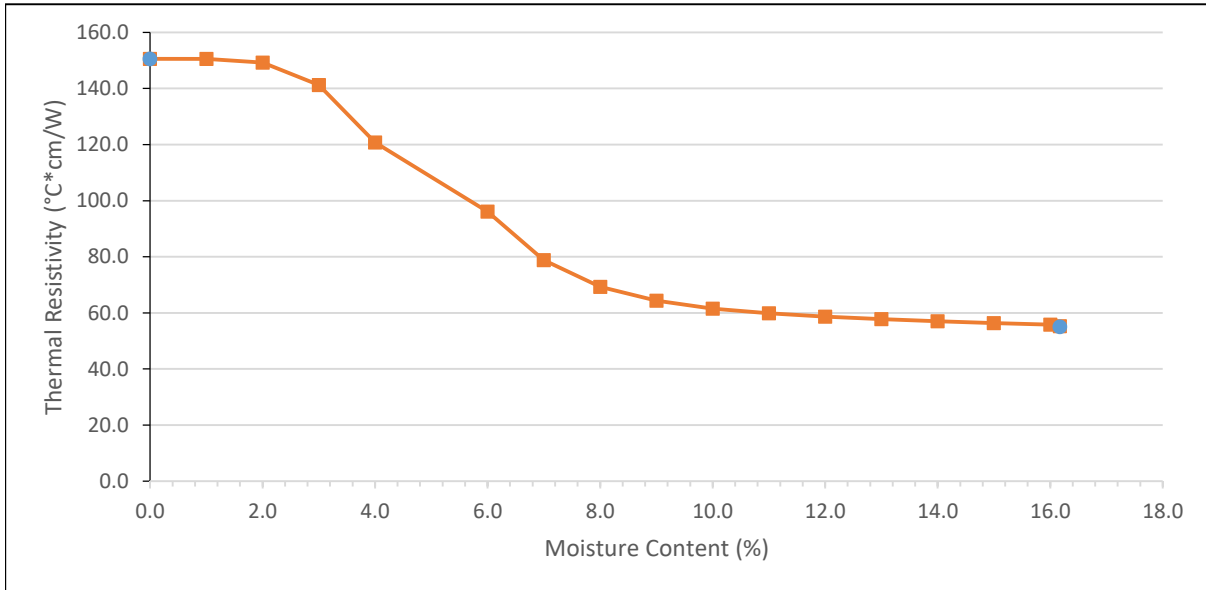
### Thermal Resistivity Dryout Curve

Moisture Content (%)	Thermal Conductivity (W/m*K)	Thermal Resistivity (°C*cm/W)
16.2	1.8183	55.0
0.0	0.6641	150.6

Optimum, Mid-Point, and Oven-Dried Test Conditions provided for Dryout Curve.  
 Maximum particle size used for reconstituted sample was 3/8".  
 Thermal dryout curve was interpolated between the oven dry and optimum water content points using Meter Group combination method.
