Subject: Pilot SWPPP Inspection Report 9/14/2021

Please find the attached SWPPP inspection report for you to review from my site visit on 9/14/2021.

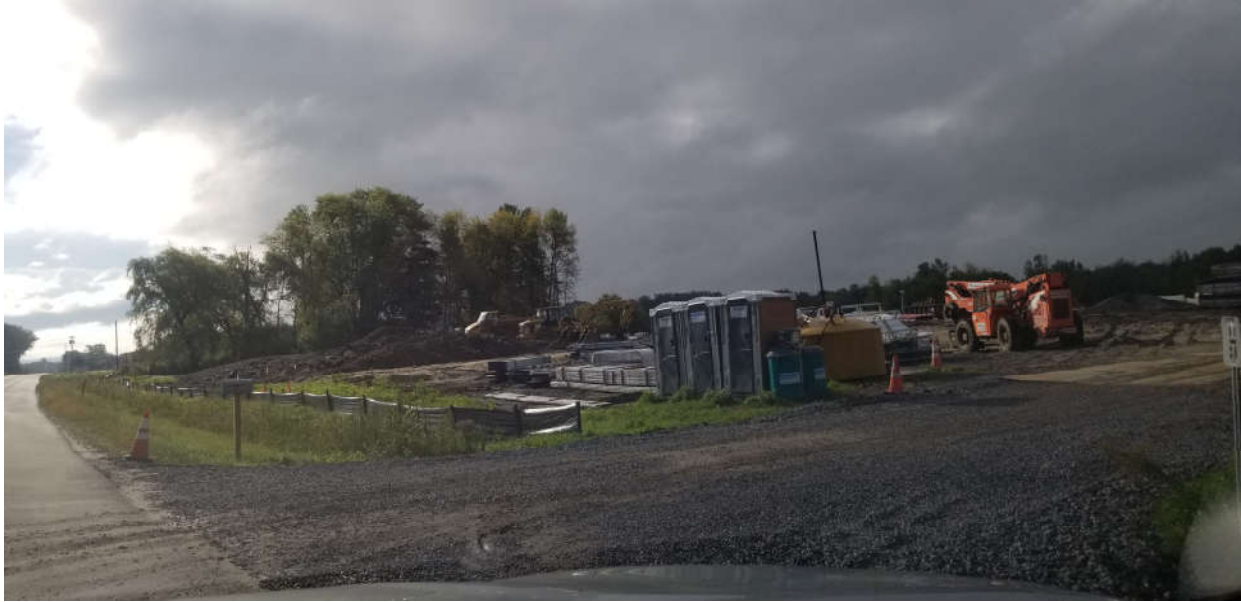
I drove past the site yesterday and things look generally good. I took the enclosed photo at the easterly side of the site along Riverside Drive. Can you please have the contractor remove some of the silt that has accumulated along the silt fence, so that the capacity is restored for the next rainfall event and the silt fence is not overtopped? It may make sense to have a second row of silt fence farther into the site and parallel with this one as it appears to be the main path of sediment movement on site.
